September 1, 1989

Re: Summary Letter Report regarding the
Fuel Oil Contamination Problem at the
Silver Residence, No. Bennington, VT.

Figure 2
Silver's Residence - North Bennington

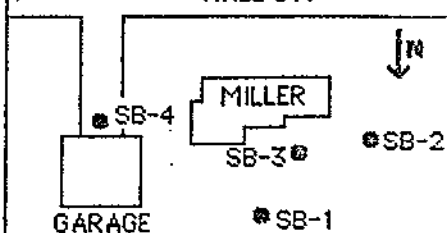
DEPTH IN FEET	WELL CONSTRUCTION	NOTES	BLOWS PER 6" OF SPOON	DESCRIPTION / SOIL CLASSIFICATION (COLOR, TEXTURE, STRUCTURES)
0		CAP		
1		NATIVE BACKFILL		
2		BENTONITE		Moist, brown, sandy CLAY, some medium gravel
3				
4				NO PETROLEUM ODOR
5				
6		GRAVEL PACK		
7		WELL SCREEN		
8				
9				Light brown, moist CLAY, little sand and gravel
10				
11				NO PETROLEUM ODOR
12				
13				
14				BASE OF EXPLORATION AT 14'
15				
16

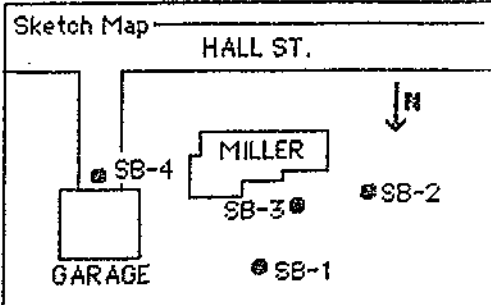
DRILLING CO. NEMC DRILLING METHOD HOLLOW STEM AUGERDRILLER TOM THORNTON LOG BY P. MURRAYWELL NUMBER SB-2

DEPTH IN FEET	WELL CONSTRUCTION	NOTES	BLOWS PER 6" OF SPOON	DESCRIPTION / SOIL CLASSIFICATION (COLOR, TEXTURE, STRUCTURES)
0				Coarse, GRAVEL fill
1				NO PETROLEUM ODOR
2				
3				Moist, brown CLAY, little medium to coarse gravel
4				NO PETROLEUM ODOR
5				
6				Wet, light brown CLAY
7				NO PETROLEUM ODOR
8				
9				
10				BASE OF EXPLORATION AT 10'
11				
12				
13				
14				
15				
16

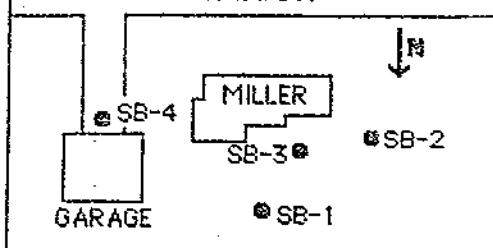
DEPTH IN FEET	WELL CONSTRUCTION	NOTES	BLOWS PER 6" OF SPOON	DESCRIPTION / SOIL CLASSIFICATION (COLOR, TEXTURE, STRUCTURES)
0				
1				Brown CLAY, little sand and medium to coarse gravel
2				
3				NO PETROLEUM ODOR
4				
5				
6				Wet, brown CLAY
7				
8				NO PETROLEUM ODOR
9				
10				BASE OF EXPLORATION AT 10'
11				
12				
13				
14				
15				
16

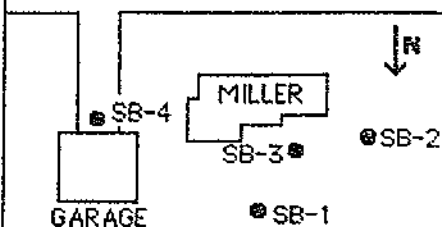
DEPTH IN FEET	WELL CONSTRUCTION	NOTES	BLOWS PER 6" OF SPOON	DESCRIPTION / SOIL CLASSIFICATION (COLOR, TEXTURE, STRUCTURES)
0				ASPHALT
1				SAND and GRAVEL fill
2				Brown CLAY, little sand and gravel
3				
4				NO PETROLEUM ODOR
5				
6				Wet, brown CLAY
7				
8				NO PETROLEUM ODOR
9				
10				BASE OF EXPLORATION AT 10'
11				
12				
13				
14				
15				
16

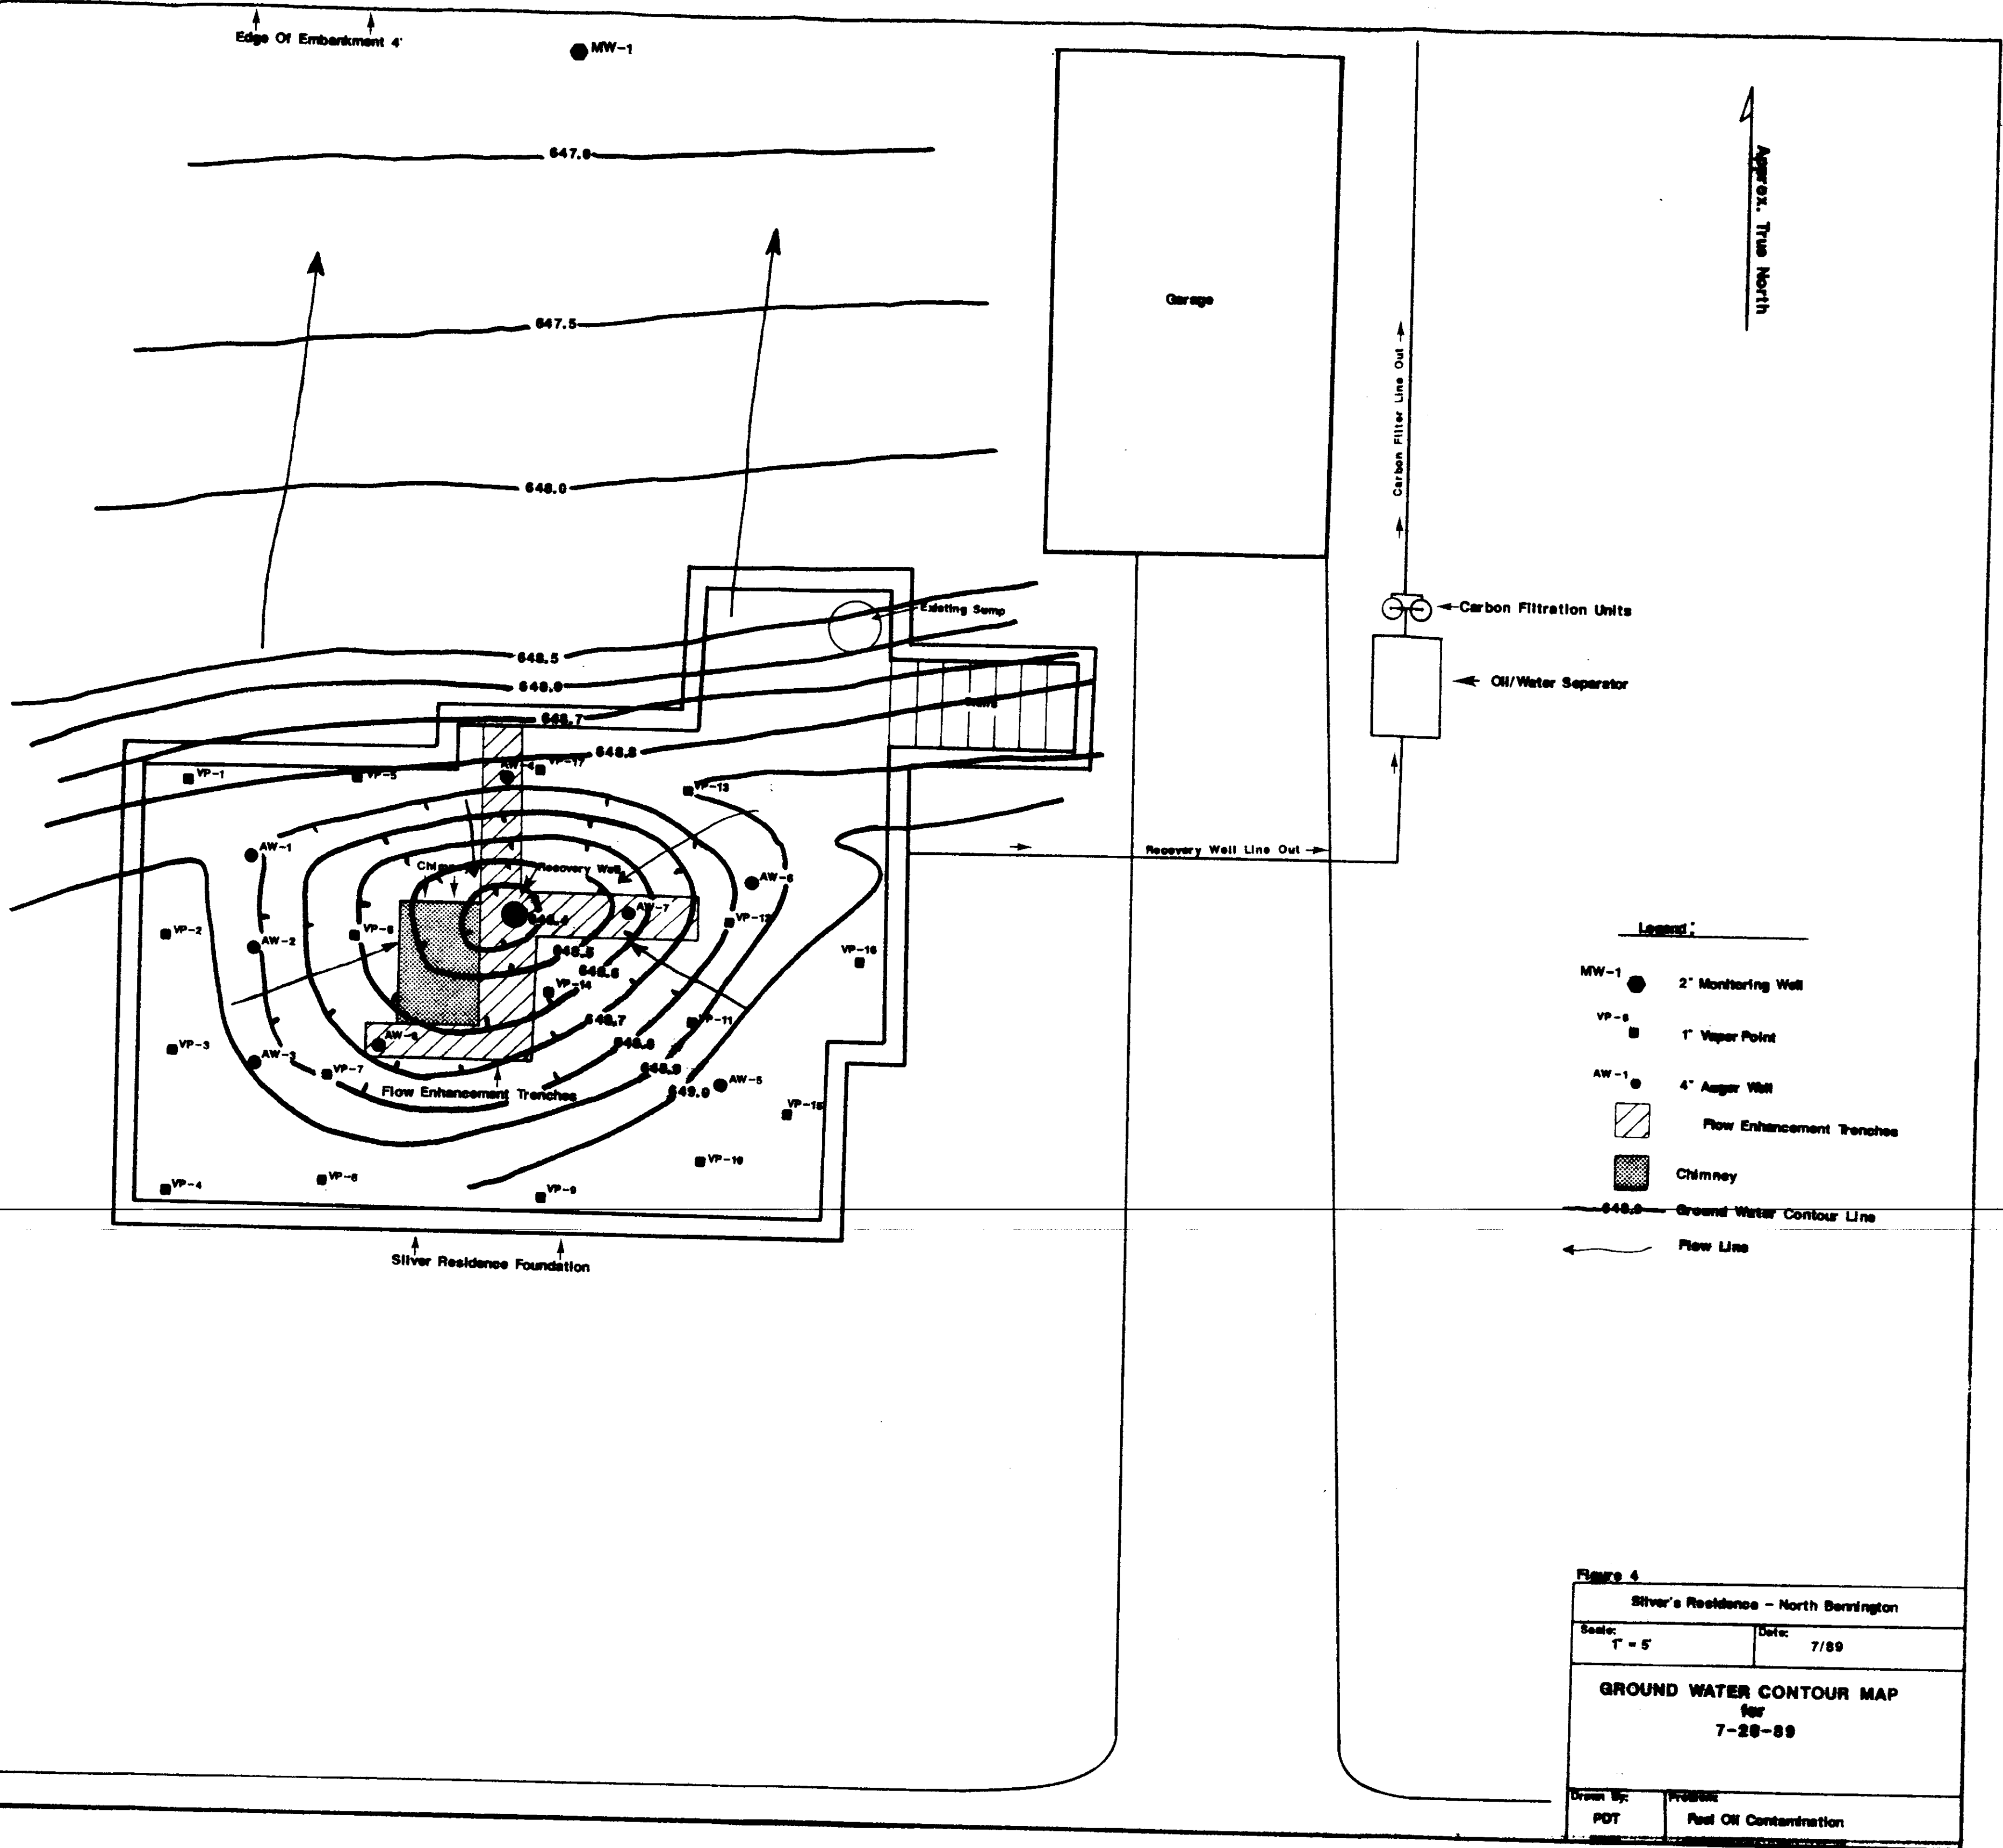
For 7-11-89

directions and flow gradients. The contour maps for data collected on July 11, July 28, and August 18, 1989 are enclosed as Figures 3 through 5 respectively. As can be seen on each of these figures, a substantial cone of depression exists in the ground water system beneath the basement floor. This cone of depression has been created by the ground water depression activities occurring in the recovery well. Normally, the ground water flow direction through the site is from south to north at a relatively steep gradient of approximately 0.042 feet per foot. Figures 3 through 5 vividly show that ground water within the basement area slopes towards the recovery well. The water and product monitoring data presented as Table 1 shows that product thickness in the basement area has decreased to a point where no free phase fuel oil is evident. The ground water elevation/product thickness data presented on Table 1 is also enclosed in graphical form as Figures 6a through 6j. Each of these graphs show how ground water elevations across the site have been steadily increasing, while product thicknesses have been steadily decreasing.
